**Flood Control Project Maintenance
Levee Inspections**

Maintenance Issue Types Only, Levee Inspection Report By Mile - Spring 2015

Reclamation District No. 0108 River Farms

Waterway	Bank	Unit Miles	Inspection Start/End	Inspector
Unit No. 01 Colusa Basin Drain	Left	20.64	04/20/2015 04/20/2015	Jai Lor

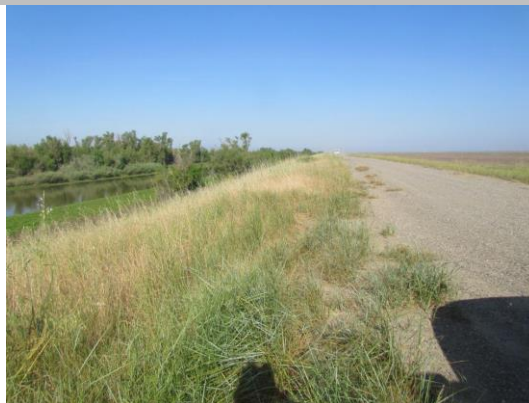
Photo 1 of 1 : SP_2015_RD0108_203_17_20150421_00010.jpg

LM Start	0.09	Rating **	M	Issue No.	17
LM End	18.82	Issue Type +	Ma	Location *	WS
Category	Earthen Levee			GPS Latitude/Longitude	
				Start	End
Item	Vegetation			38.823146 °	39.012007 °
				-121.797630 °	-121.979559 °
DWR ID	DWR_RD0108_01_s_2015_17				
Action/Comments					
Control annual grass and weeds on the levee slopes and easements.

View of the vegetation on the water ward side of the levee looking upstream. Spring 2015.

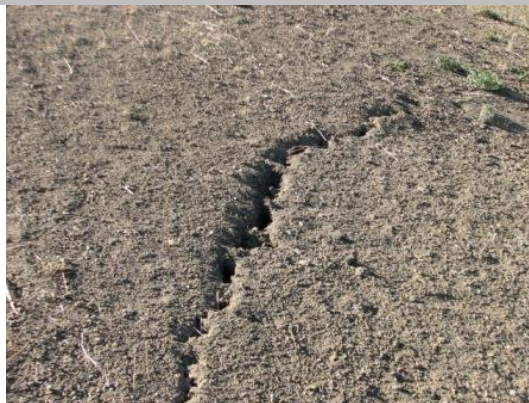
Photo 1 of 2 : SP_2015_RD0108_203_279_20150401_00007.jpg

LM Start	9.29	Rating **	A/W	Issue No.	279
LM End	9.29	Issue Type +	Ma	Location *	WS
Category	Earthen Levee			GPS Latitude/Longitude	
				Start	End
Item	Slope Stability			38.897452 °	38.897452 °
				-121.914680 °	-121.914680 °
DWR ID	DWR_RD0108_01_f_2013_279				
Action/Comments					
Repair slope instability.

The cracking runs in a horseshoe pattern on the levee slope. Fall 2013

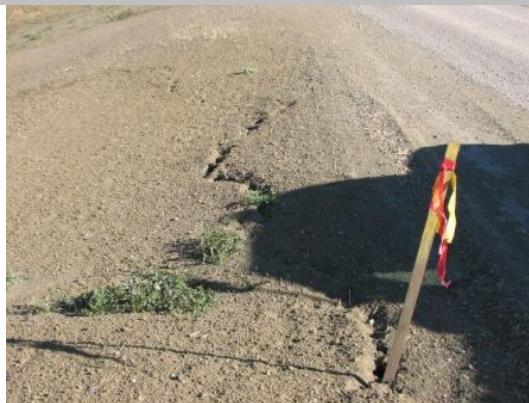
Photo 2 of 2 : SP_2015_RD0108_203_279_20150401_00008.jpg

LM Start	9.29	Rating **	A/W	Issue No.	279 (cont)	
LM End	9.29	Issue Type +	Ma	Location *	WS	
Category	Earthen Levee			GPS Latitude/Longitude		
				Start		End
Item	Slope Stability			38.897452 °	38.897452 °	
				-121.914680 °	-121.914680 °	
DWR ID	DWR_RD0108_01_f_2013_279					
Action/Comments						
Repair slope instability.

Slope stability with cracking 1-2 inches open and 12 inches deep. The district is monitoring the site. Fall 2013

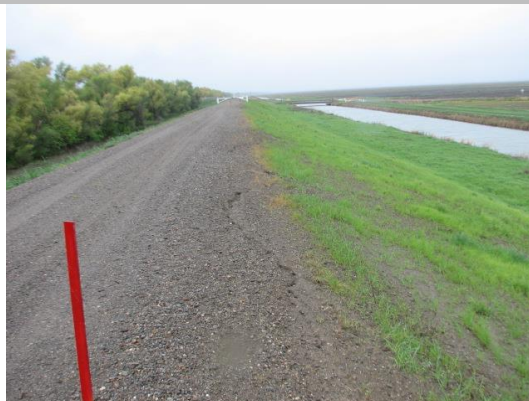
Photo 1 of 1 : SP_2015_RD0108_203_12_20150401_00006.jpg

LM Start	14.49	Rating **	M	Issue No.	12
LM End	14.49	Issue Type +	Ma	Location *	LS
Category	Earthen Levee			GPS Latitude/Longitude	
				Start	End
Item	Cracking			38.967243 °	38.967243 °
				-121.923407 °	-121.923407 °
DWR ID	DWR_RD0108_01_s_2014_12				
Action/Comments					
Schedule repair of subsidence prior to the next inspection.

Cracking along the shoulder of the crown. Some slope instability has occurred. Spring 2014

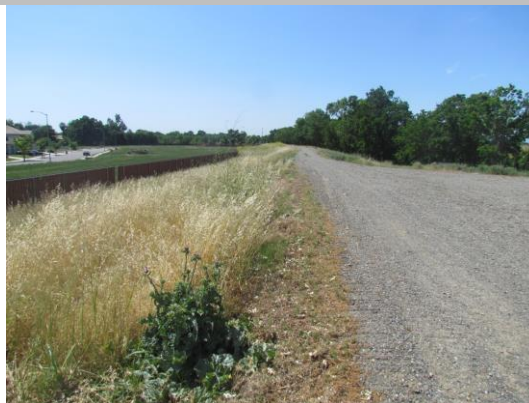
Photo 1 of 1 : SP_2015_RD0108_590_1_20150421_00003.jpg

LM Start	0.09	Rating **	M	Issue No.	1
LM End	0.28	Issue Type +	Ma	Location *	LS
Category	Earthen Levee			GPS Latitude/Longitude	
				Start	End
Item	Vegetation			38.797091 °	38.799138 °
				-121.726729 °	-121.724456 °
DWR ID	DWR_RD0108_02_s _ 2015_1				
Action/Comments					
Control annual grass and weeds on the levee slopes and easements.

View of the vegetation on the landward side of the levee looking downstream. Spring 2015.

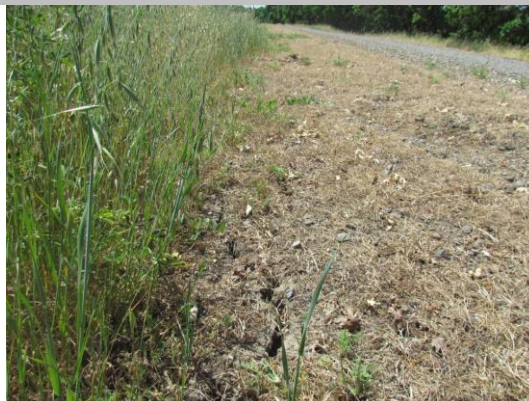
Photo 1 of 1 : SP_2015_RD0108_590_5_20150421_00004.jpg

LM Start	0.17	Rating **	A/W	Issue No.	5
LM End	0.17	Issue Type +	Ma	Location *	LS
Category	Earthen Levee			GPS Latitude/Longitude	
				Start	End
Item	Cracking			38.797922 °	38.797922 °
				-121.725865 °	-121.725865 °
DWR ID	DWR_RD0108_02_s _ 2015_5				
Action/Comments					
Monitor and have inspected by geotechnical engineer.

View of the crack on the landward side of the levee looking downstream. Spring 2015.
